# Reduction of water pollution in salt marshes through biotechnical measures

Case study

**Project name:** Complex ecological restoration of degraded and disappearing salt marshes in Moravian Pannonia (LIFE in Salt Marshes)

**Type of output:** Case study (deliverable D2.3)

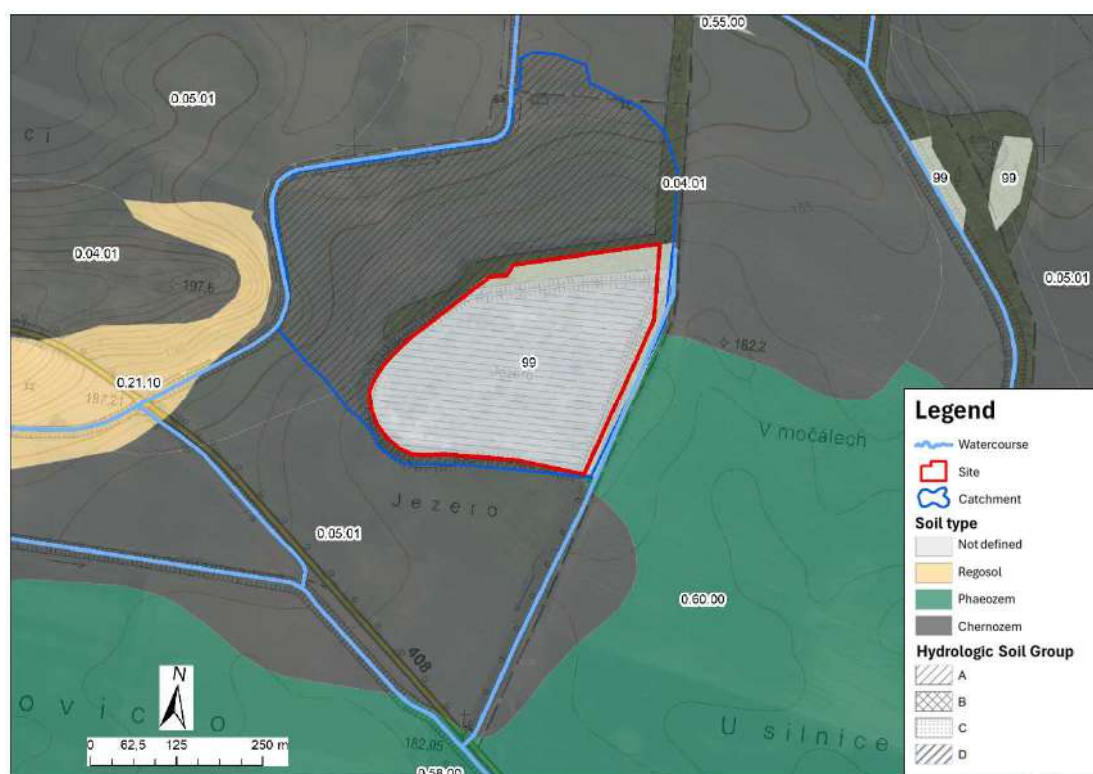
Figure 14: Soil cover in the SAC site Hevlínské jezero

The soil cover (Fig. 14) outside the waterlogged area predominantly comprises Chernozem (BPEJ 0.04.01 and 0.05.01 – Chernozems primarily on flat or completely flat terrains with all-direction exposure and skeletal content below 25%). The soils are deep to moderately deep, located in a very warm, dry climatic region, and are of low productivity. A belt of forest soil occurs at the northern edge of the wetland. The SAC and its surroundings fall into Hydrological Soil Group A, characterized by high infiltration rates and low water retention capacity.

Figure 14: Soil cover in the SAC site Hevlínské jezero

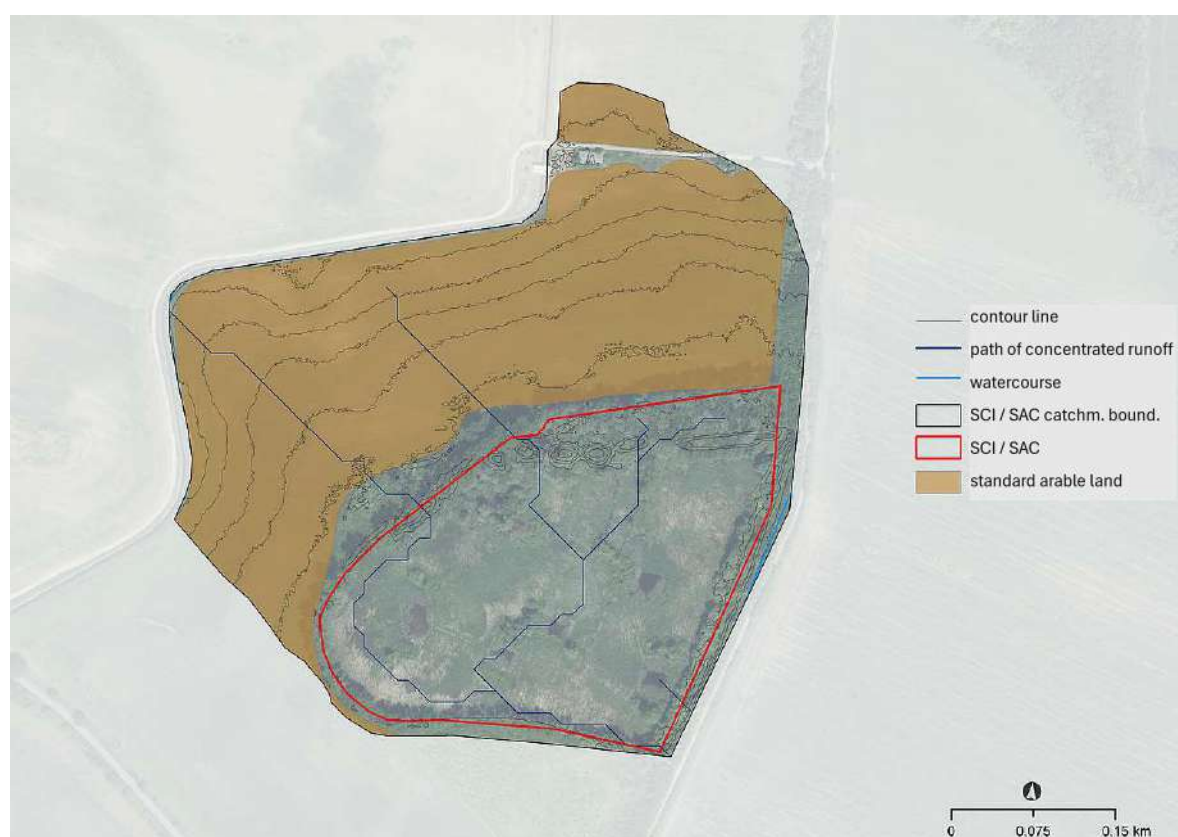
Figure 15: Land use in the catchment area of the SAC Hevlínské jezero

Within the catchment of SAC Hevlín Lake, two concentrated runoff pathways were identified (Fig. 15), which flow southeast across the catchment area toward the NW boundary of the SAC and may represent potential sources of pollution during significant rainfall-runoff events. There is no sewer infrastructure or wastewater treatment plant within the catchment, thus eliminating the possibility of municipal pollution. Potential sources of diffuse pollution include surrounding arable land and possibly contaminated groundwater feeding the lake.

Figure 15: Land use in the catchment area of the SAC Hevlínské jezero

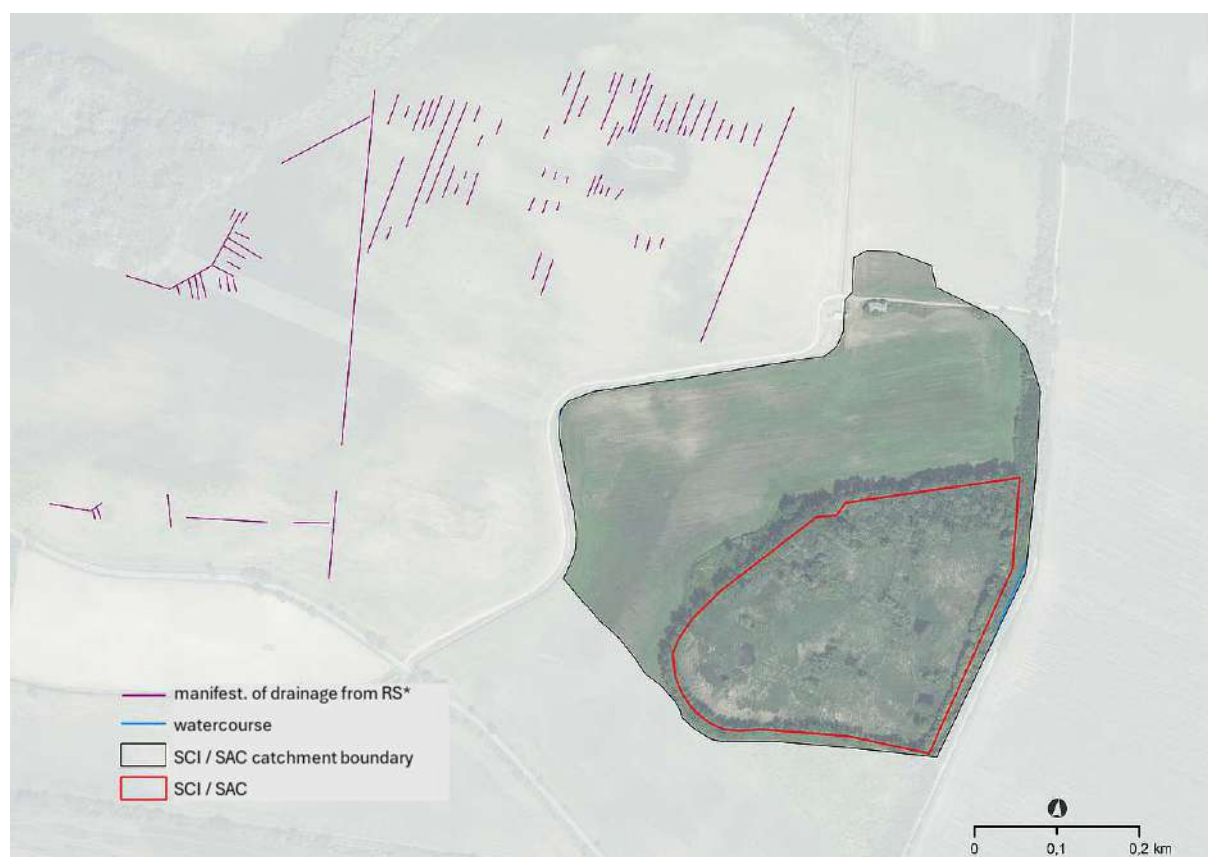
Figure 16: Sources of water pollution in the catchment area of the SAC Hevlínské jezero

The water quality of the SAC is only minimally threatened by point or diffuse pollution sources. The Krhovice–Hevlín main irrigation canal runs along the northwest edge of the SCI catchment but is topographically separated from the site by a terrain incision. No agricultural drainage systems were identified in the SAC area. However, the arable land in the northern part of the catchment is intensively irrigated. Water infiltrating from this irrigation into the lake could pose a potential risk to water quality, as could surface runoff during extreme rainfall-runoff episodes—particularly along two concentrated runoff paths (Fig. 15), which flow southeast across the catchment into the NW corner of the SAC. No sewer systems or wastewater treatment plants are present in the catchment, thus excluding municipal pollution as a risk factor for lake water quality.

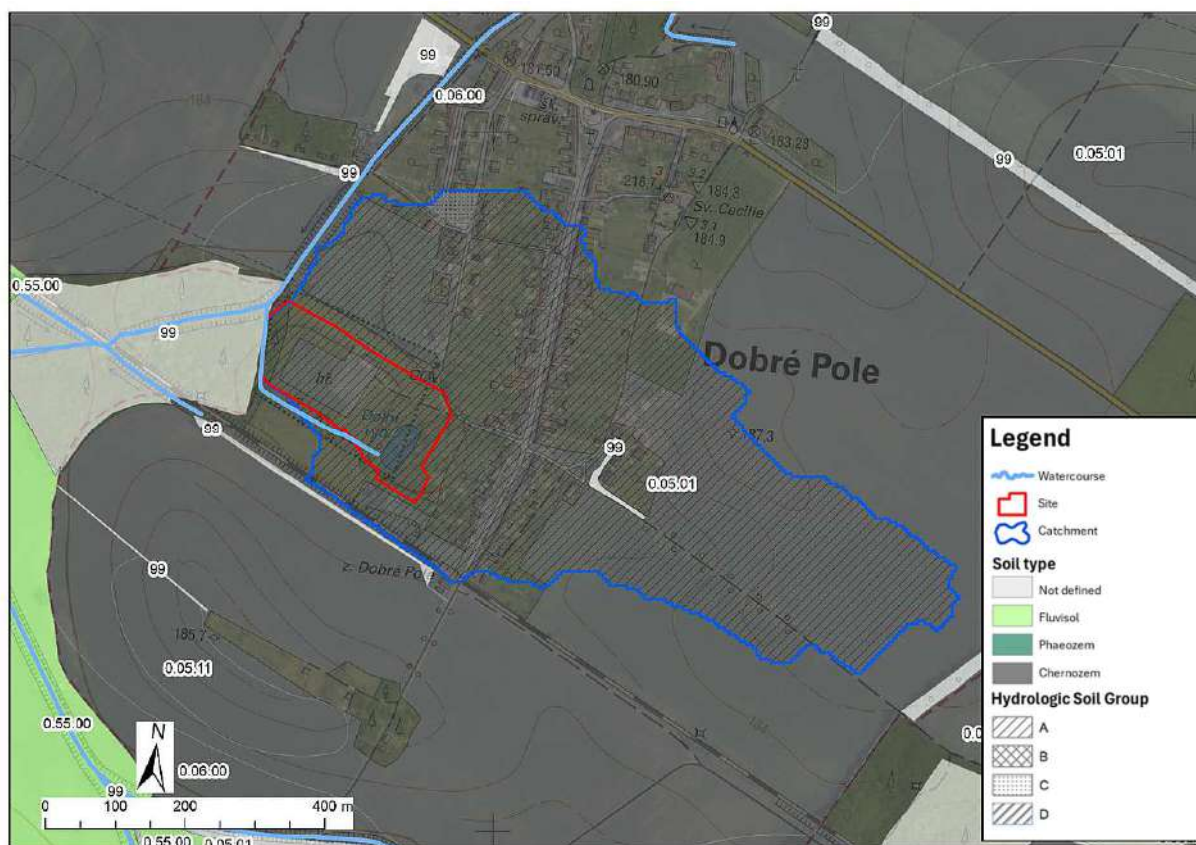
Figure 35: Soil cover at the area of SCI Dobré Pole

Figure 35: Soil cover at the area of SCI Dobré Pole

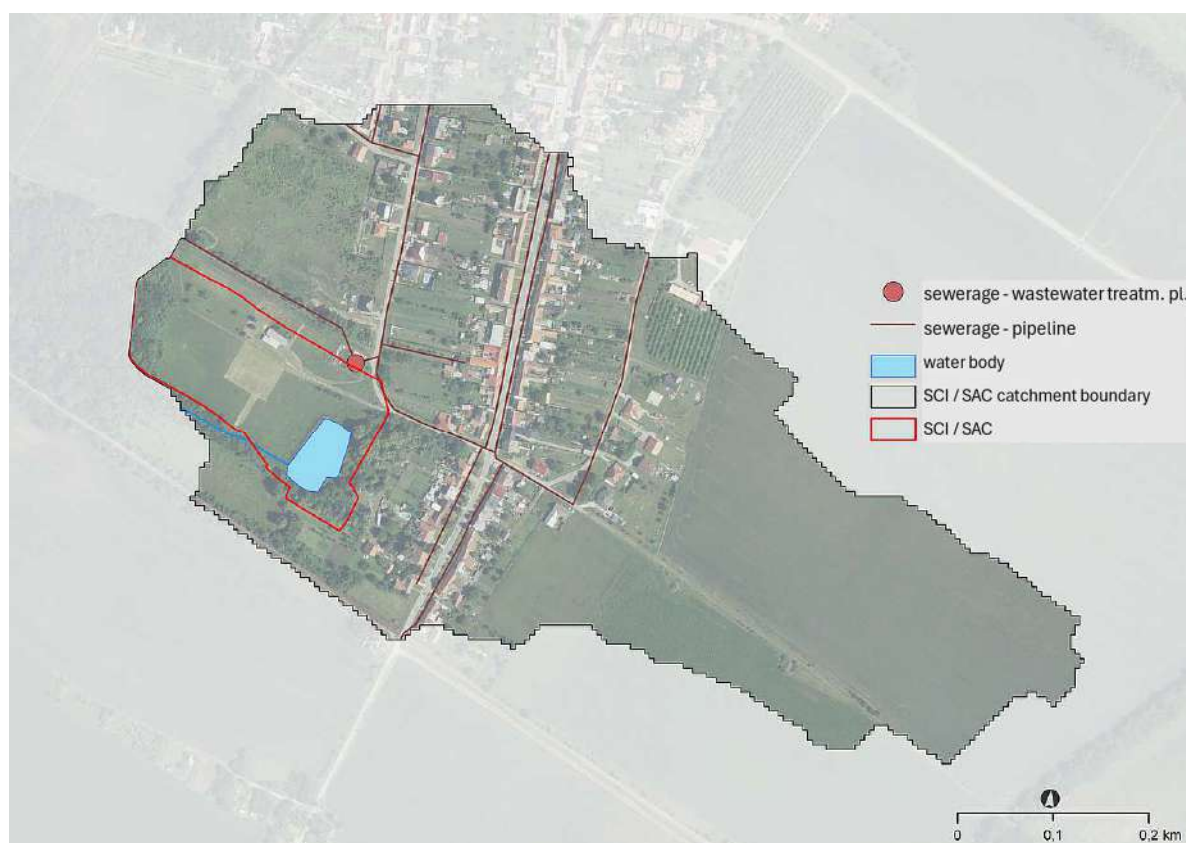
Figure 37: Sources of water pollution in the catchment of SCI Slanisko Dobré Pole

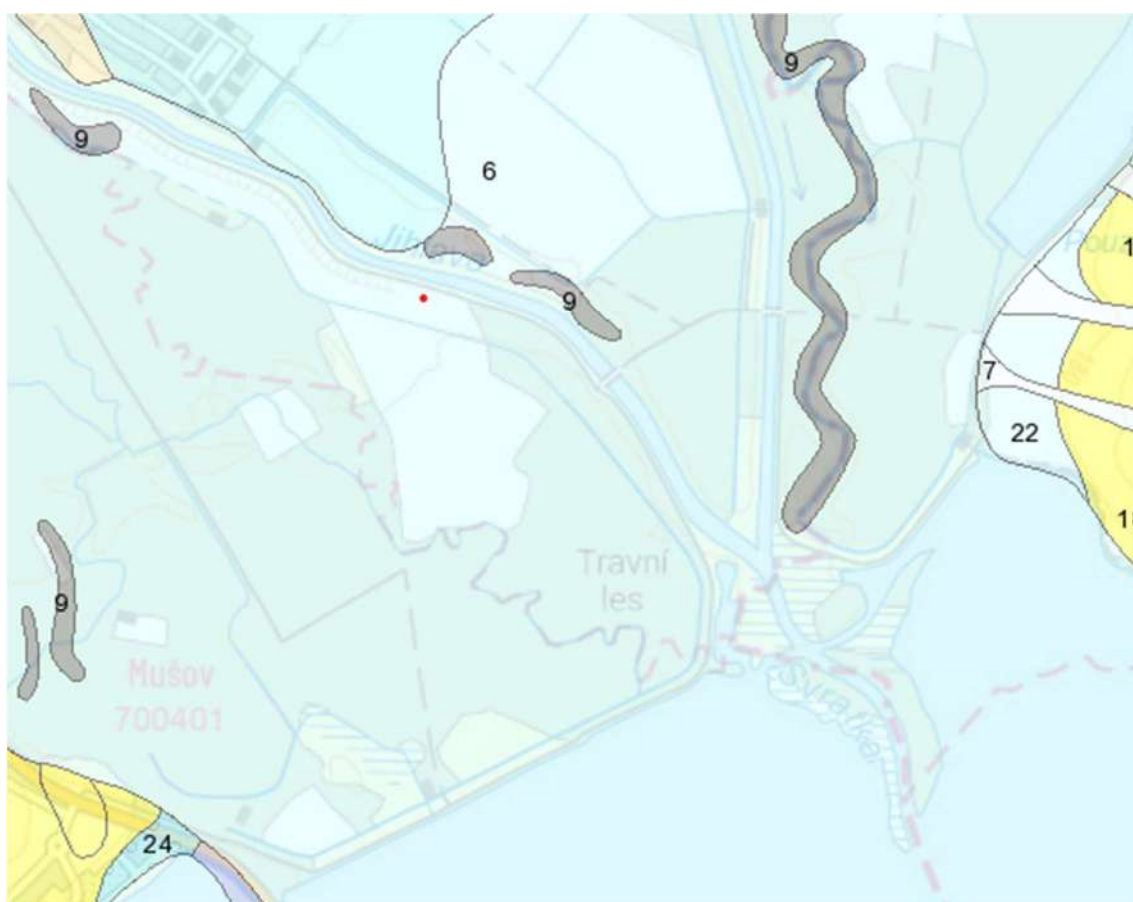
Figure 41: Geological map of the Husí pastviště site (ČGS database): 6 – alluvial sediment; 1824 – calcareous clay (schlier) with interbedded calcareous sands and gravels

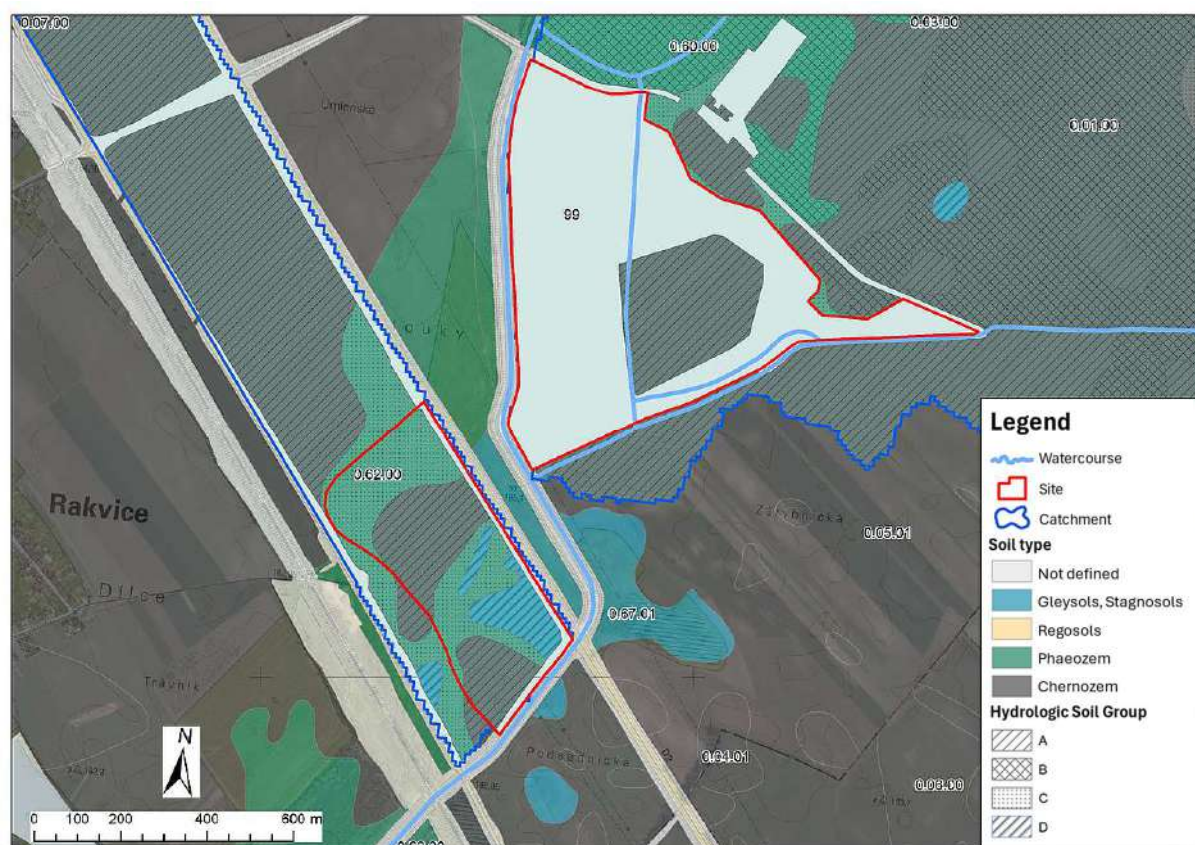
Figure 52: Soil cover of SAC Trkmanské louky

The soil cover (Fig. 52) is primarily composed of chernic soils and chernozems, with gley soils present along the eastern boundary of the site. From a hydropedological perspective, chernic soils belong to hydrological group C (soils with low infiltration rates, 0.02–0.06 mm/min, typically with a low-permeability horizon and a clay loam to clay texture), chernozems to group A (soils with high hydraulic conductivity), and gley soils to group D (soils with very low saturated hydraulic conductivity).

Figure 52: Soil cover of SAC Trkmanské louky

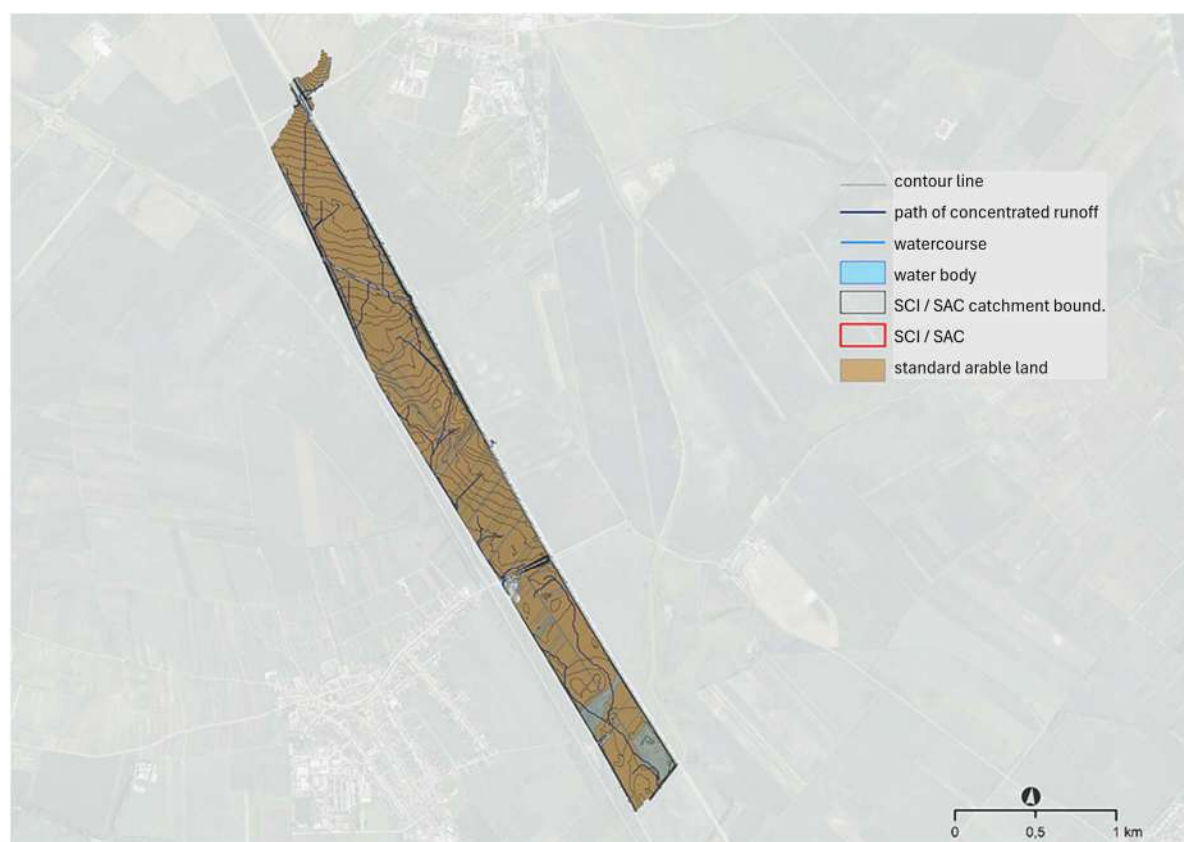
Figure 53: Land use in the SAC Trkmanské louky catchment

Figure 53: Land use in the SAC Trkmanské louky catchment

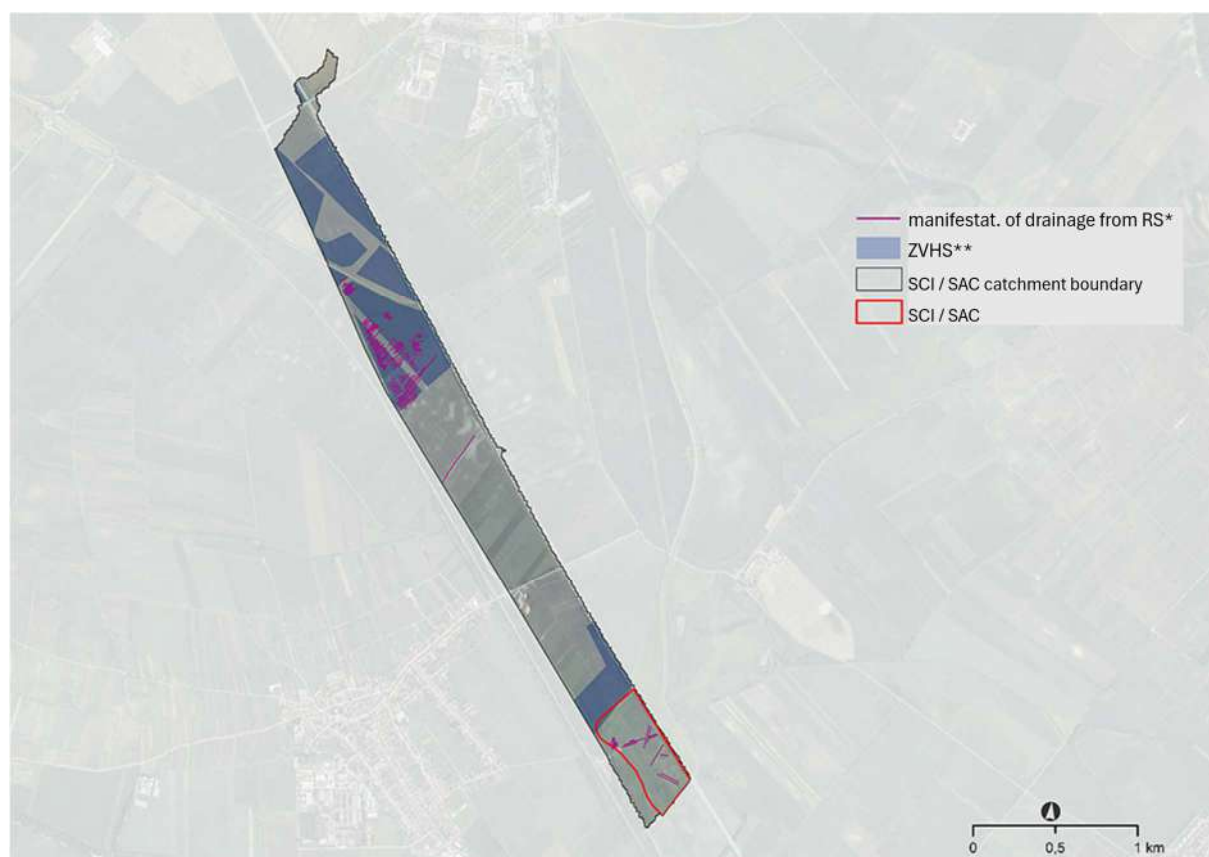
Figure 54: Sources of water pollution in the catchment of SAC Trkmanské louky

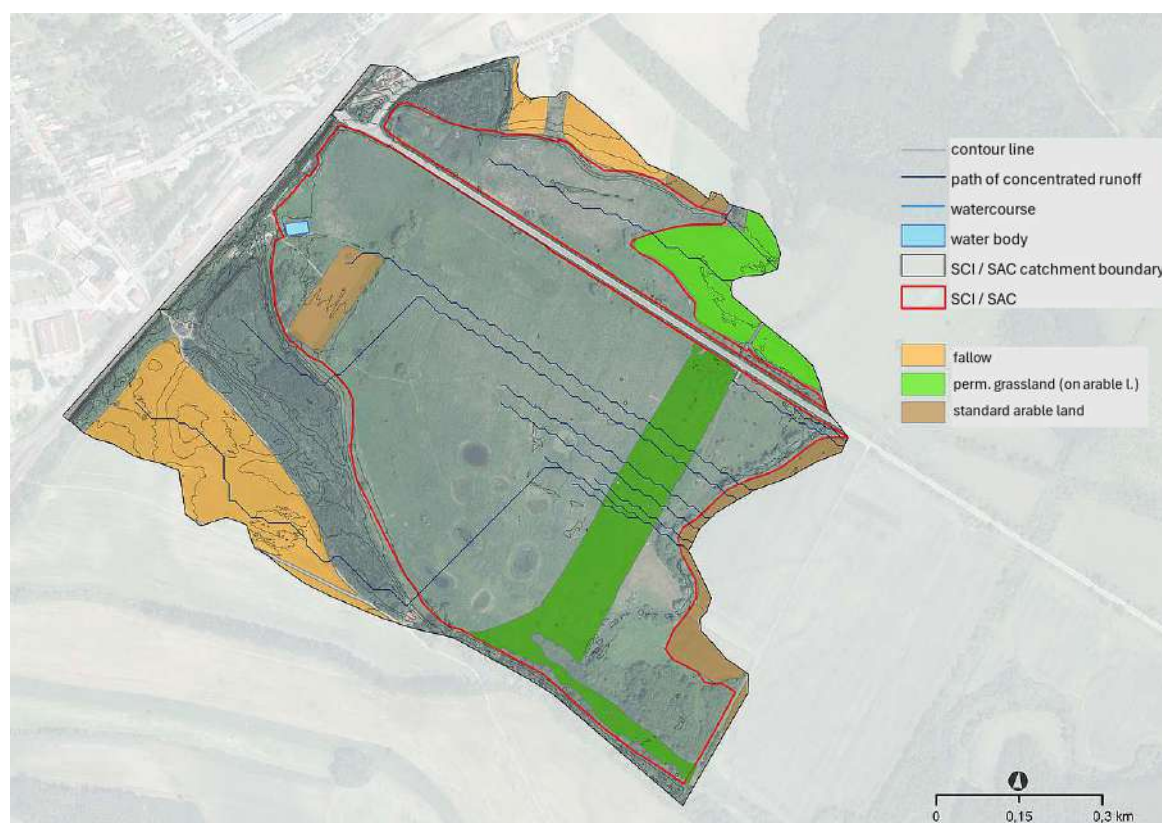
Figure 63: Land use in the Vypálensky SAC catchment

The Vypálensky SAC spans 65.3 ha and has a contributing catchment of 101.4 ha, only slightly extending beyond the SCI boundaries. According to LPIS data, agricultural land covers just 23.9% of the area (Fig. 63), with arable land comprising only 3.6%. The site is relatively hydrologically isolated, with most water derived from groundwater and precipitation. No inflow from surrounding streams or drainage canals was detected. An artificial pond and a presumed stormwater outlet are located in the northwestern part, while municipal wastewater from Moravský Písek is treated in Vracov. Several minor concentrated runoff paths were identified running northwest–southeast. According to the ZVHS database, no agricultural drainage systems are recorded in the area, and remote sensing analysis confirmed the absence of any such systems.

Figure 63: Land use in the Vypálenky SAC catchment

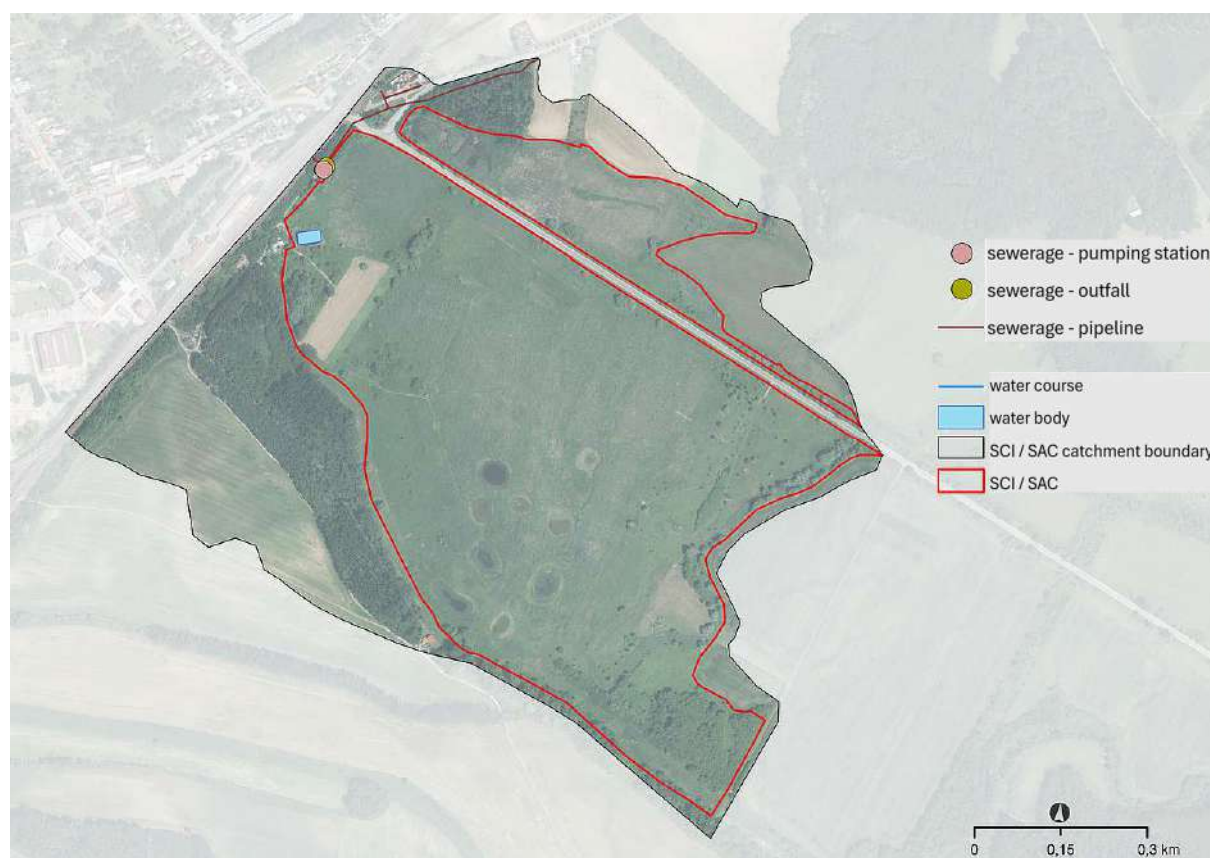
Figure 64: Water pollution sources in the Vypálensky SAC catchment
